# THE SHARD

## The Scheme

The Shard at London Bridge is the tallest structure in the UK. It is founded on a three level basement formed with a Hard-Firm Secant Wall. Bearing piles are founded in the Thanet sand and had plunge columns to allow a top down construction. Contract value £14 Million.

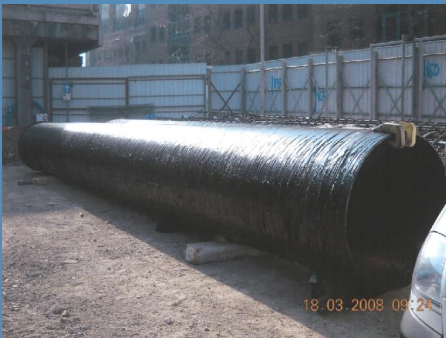
Slip Liner

- Compressive loading up to 24MN.
- Max pile length 56.5m, founding in the Thanet sand.
- Preliminary Test pile carried out
  - 19.5m Bitument coated slip liner used
  - 1200mm diameter pile
  - Strain gauges at strata interfaces
  - 7kN/m<sup>2</sup> bond stress over slip liner
  - 161 kN/m<sup>2</sup> bond stress measured in London Clay
  - 113 kN/m<sup>2</sup> bond stress measure in lower London Clay and Upper Lambeth.
  - 176 kN/m<sup>2</sup> bond stress measured in the lower Lambeth.
  - Total pile settlement 37mm at 30 MN.
  - Pile left open 2 days with bentonite prior to testing.
- Piles designed to over FOS = 2.5

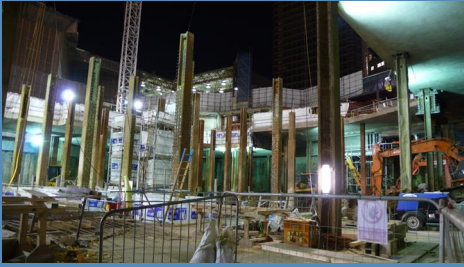
Excavation showing ring beam

- Existing piles. The bells of underream piles were cored through. The line of the secant wall was modified to locally avoid existing pile.
- The ground floor propping in the top down area was constructed as a ring beam. The superstructure was started from the B1 slab level not the ground floor level.

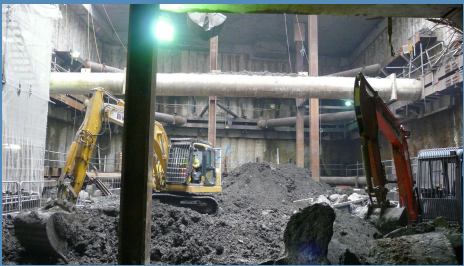
Excavation

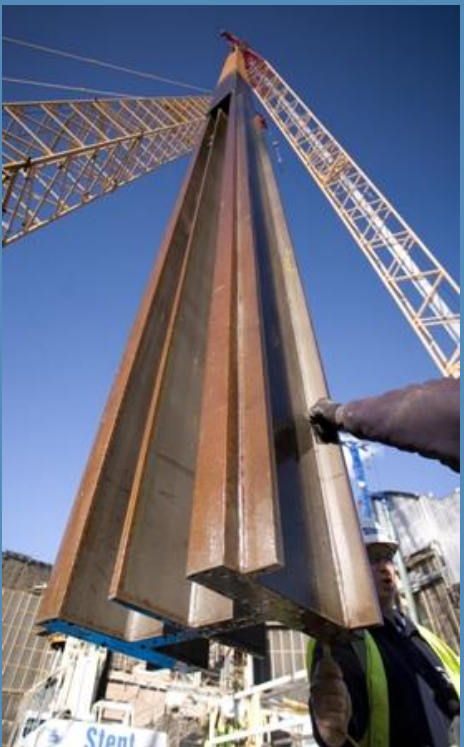
Plunge Column with fins  
To increase surface area

- There was an area of bottom up construction in the car-stacking area – this eased excavation of the basement.
- The plunge columns were used as support for the tower cranes.
